IDENTIFICATION AND INTERPRETATION  
OF MINERALOGICAL INFILTRATION  
OCCURRING IN A CHROME REFRACTORY  
COLLECTED IN THE  
SUDBURY, ONTARIO REGION

A Thesis

Presented in Partial Fulfillment of the  
Requirements for the Degree Bachelor of Science

The purpose of this paper is to explain the mineralogical changes that have occurred in a brick taken from a Sudbury copper smelter. A distinct color change is observable across a slab cut from the brick. The scanning electron microscope and computer x-ray analysis program explain the color changes. The x-ray images obtained indicate the brick is composed of magnesia and chrome spinel with very poor crystal bonding. It is this poor bonding that allows material to infiltrate the brick. It was found that copper was the major infiltrated element; however, trace amounts of sulfur, iron, and nickel also were observed. It appears that these elements derived from the processed ore do affect the mineralogy. The color change is the result of new minerals infiltrating the brick matrix. Native copper and cuprite have been clearly identified and there is a strong possibility that additional copper, iron, and nickel minerals have infiltrated to a less

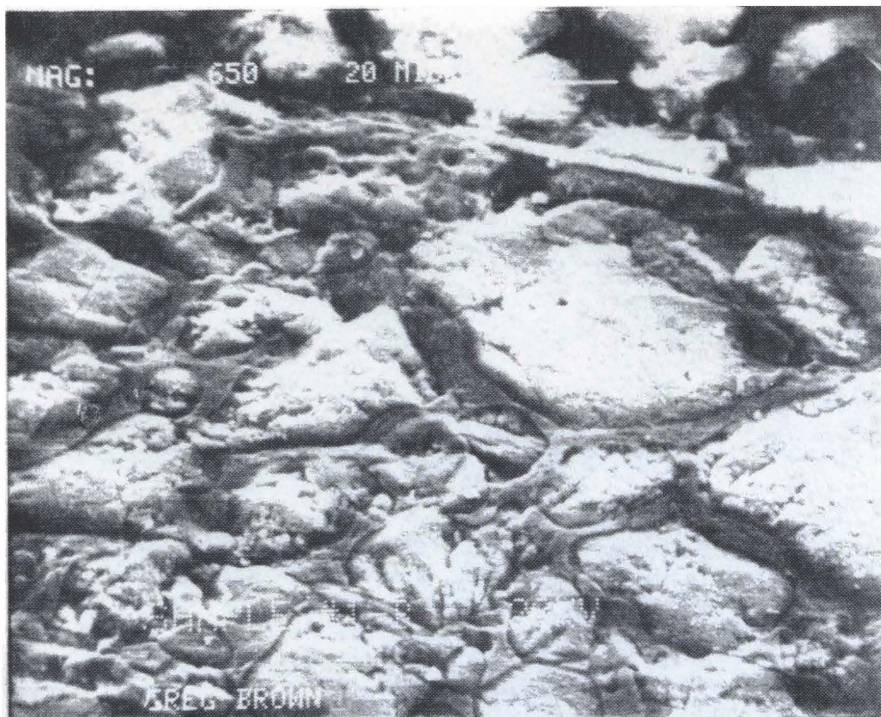
Figure 4.  
SEM micrograph of sample #1-B showing composition of crystals when used with x-ray images provided below.

A very effective way to illustrate crystal identification and determination is to use both SEM micrographs and mapping data. Mapping data includes both elemental x-ray distribution images and video images as well as composite images made from both. Figure 4. a micrograph of sample #1-B clearly shows three different crystals. When used inconjunction with figure 5. the three different crystals become clear. Figure 5. shows a x-ray image of four elements on left side. On the right side is a video composite image showing the distribution of both magnesium (red) and copper (blue), over-lap of the elements produce the lighter violet color. What these two figures show is that chrome spinel crystals are present in the upper left-hand corner. Periclase is the remaining crystals with a copper network streching around both the periclase and spinel crystals.

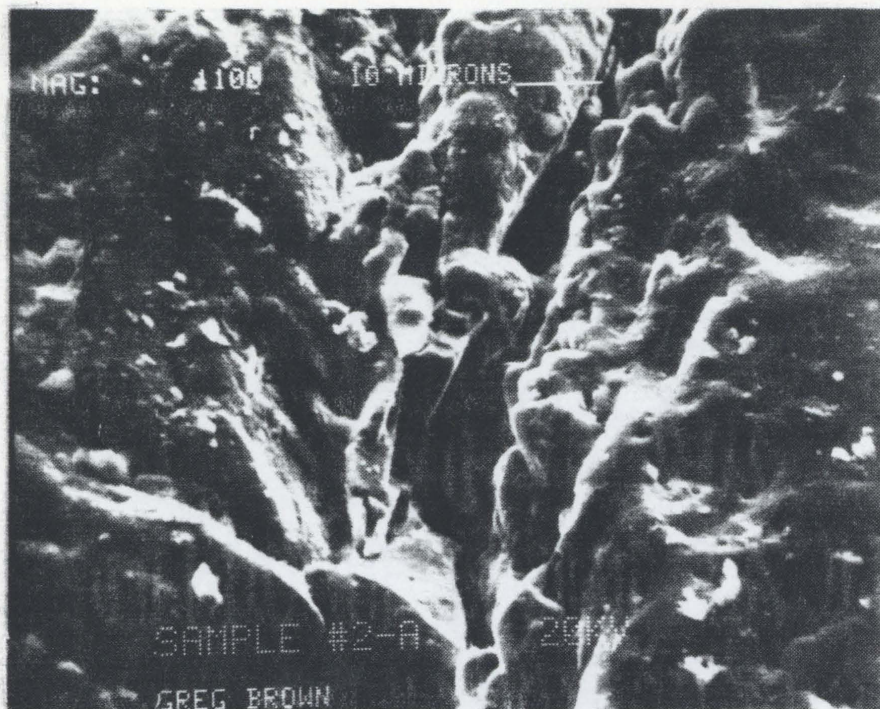
Figure 6.  
SEM micrograph of sample #2-A showing composition of brick. Use with x-ray images provided below.

Perhaps another set of figures will explain the determination of the crystal composition. Figure 6. a micrograph of sample #2-A shows distinct crystals of periclase (left side) and chrome spinel (right side). A x-ray image and composite video of figure 7. show the location of three major elements. The composite video shows distinct crystal forms by color coding periclase (red), copper (blue) and chrome spinel (yellow-green). The x-ray map of Fe shows a high concentration of this element in the spinel crystal, further proof that the crystal is chrome spinel and not chromite.

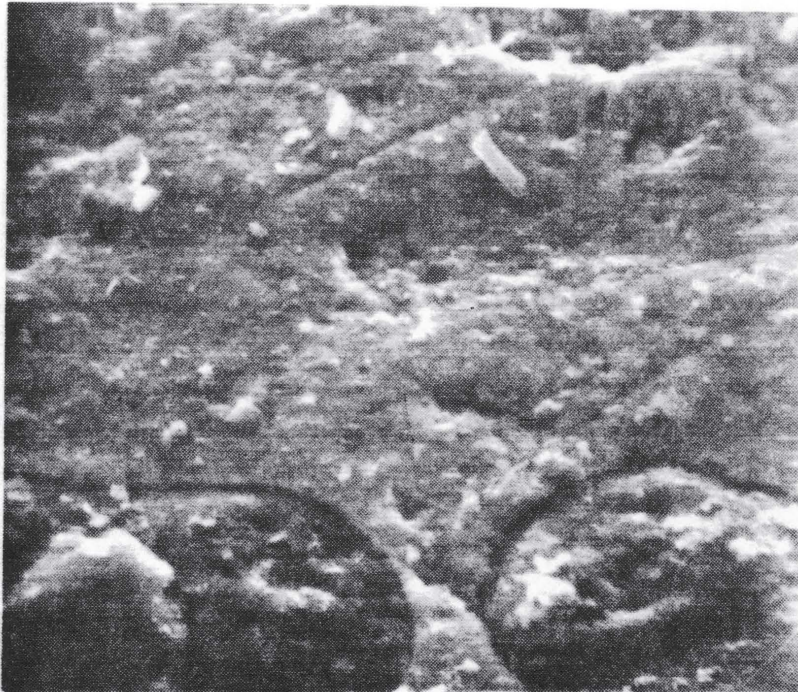
Figure 20.  
SEM micrograph of sample #7-A showing infiltration  
of copper. Width of photo is 50 microns. Mag. 2,200x

Further evidence of copper infiltration is shown in figures 19. and 20. These figures show copper filling voids such as a mud slide might fill a river valley. Note however that these figures show copper infiltration in two different locations on the brick. Refer again to figure 3. which illustrates those sample locations. Also use figure 3. to observe the location of sample #1, since figures 21., 22., 23., and 24. are taken from this sample. Figure 21. shows a composite x-ray map of the distribution of copper in this sample. Copper designated by the color blue appears as before to fill in areas of low relief. Figure 22. show the same area in black and white. Figure 23. is a combination of x-ray images and video image which allows easy tracing of the route taken by copper. Figure 24. an SEM micrograph shows the unique stretching effect of copper as it forms a connective network across sample #1-B. It was stated that copper was the only definite mineral found to have infiltrated the Sudbury brick. This is the only mineral that SEM analysis provided evidence for. However not detected in x-ray mapping is the presence of cuprite ( $\text{Cu}_2\text{O}$ ), which was found in polished sections and x-ray diffraction patterns. The SEM elemental x-ray analysis program cannot detect oxides thus the reason cuprite was not found in any of the samples.

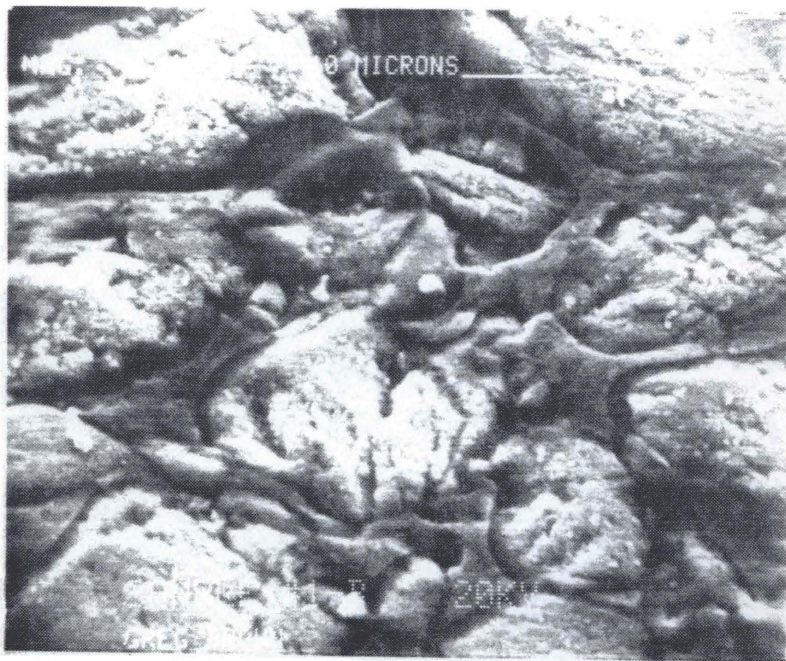
Figure 24.  
SEM micrograph of sample #1-B showing infiltration  
of copper at high magnification.

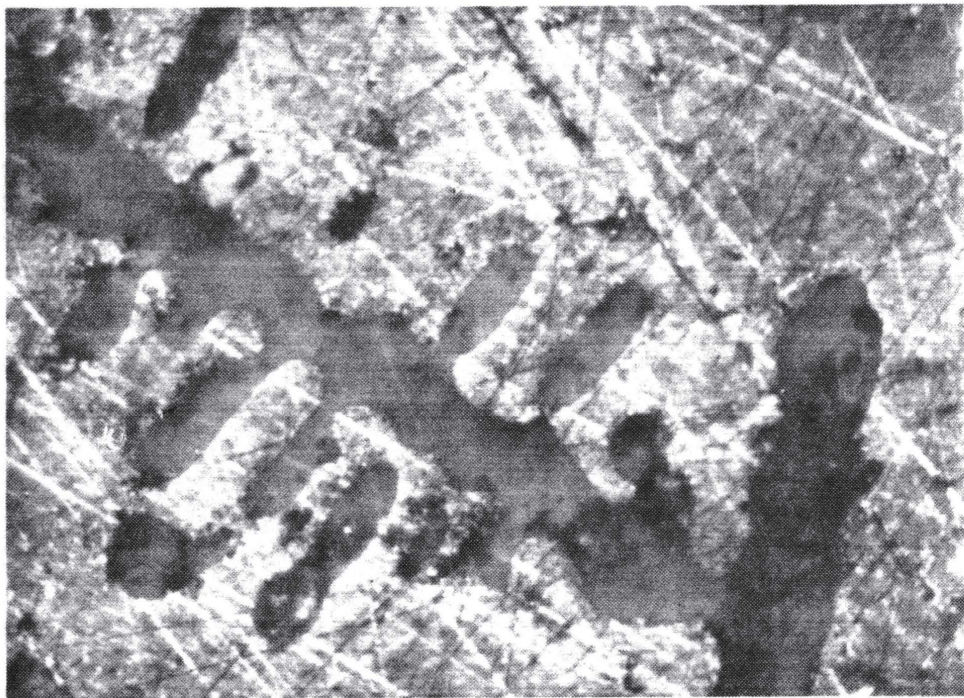
Figure 25.  
Photomicrograph of cuprite in a copper bleb under  
crossed nicols. Photo width is 550 microns.  
Mag. 200x

Polished sections showed a great deal more than the thin-sections as far as mineral identification. A prime example of this is shown in figure 25. and 26. Figure 25. shows the brilliant red internal reflections of cuprite under crossed nicols. Figure 26. shows the cuprite under uncrossed nicols. Notice the copper surrounding the cuprite. The scratches as well as the color in crossed and uncrossed nicols confirm this material as copper. Notice how the cuprite seems to form separate blebs. Many of these blebs become circular inclusions within the copper. Perhaps this disassociation effect between copper and cuprite is the reason that copper is only oxidized around the fringes of the brick, cuprite forms and separates, allowing copper to travel further into the brick.
